PRODUCT SAFETY NOTICE CORRECTIVE ACTION

DEWALT DWS780-XE and DHS780 305mm Mitre Saws

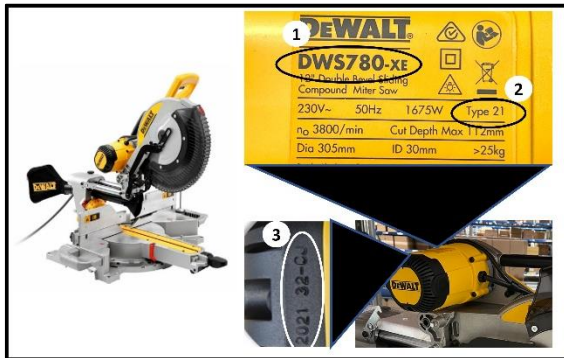
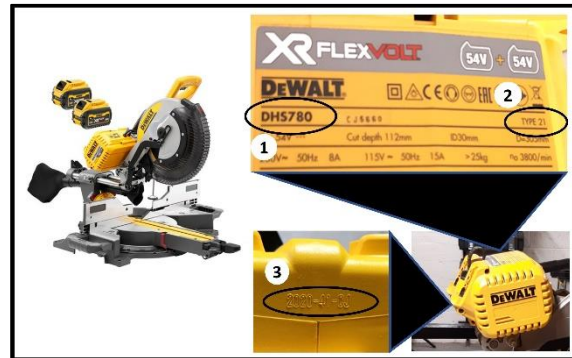
1. Models: DWS780-XE, DHS780
2. Type Number: 21
3. Production Date Codes: Between 2019-33 and 2022-06

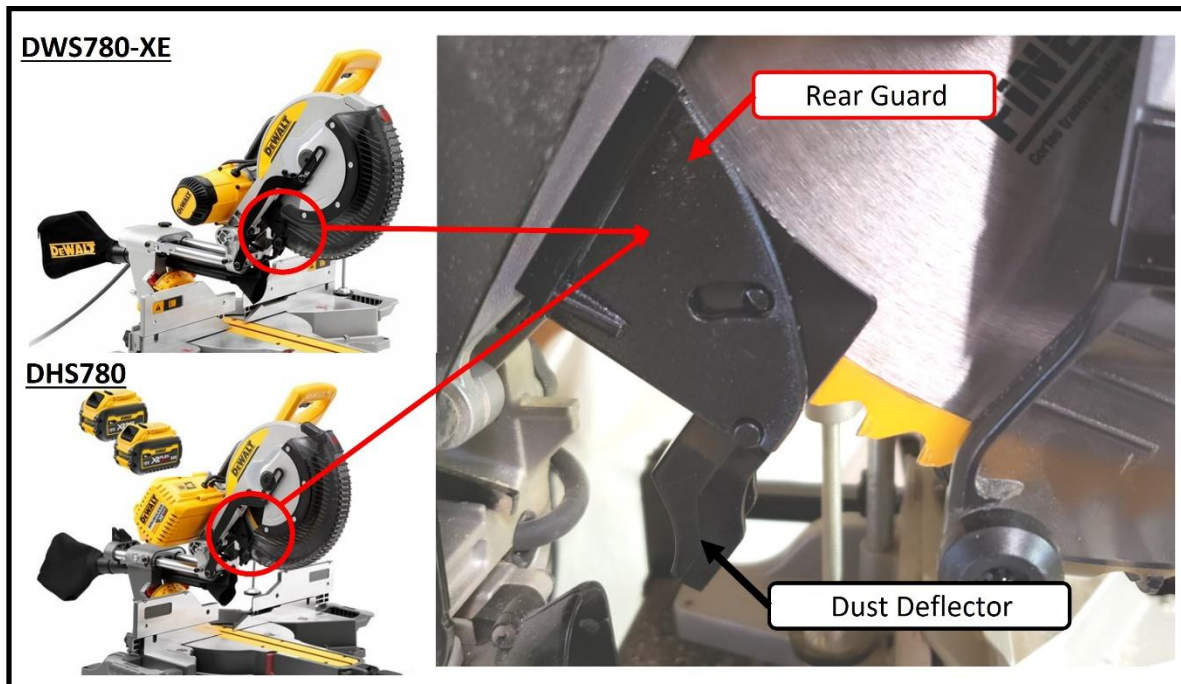
REAR GUARD COMPONENT LOCATION AND IDENTIFICATION

Defect: The rear guard may break or detach and make contact with the saw blade.

Hazard: If the rear guard contacts the saw blade, fragments may be thrown from a rotating blade contacting the operator or bystander and causing injury.

The repair kit includes a new rear guard and dust deflector assembly, two new fixing screws and instructions. The original saw blade wrench supplied with the saw, which is used to change saw blades, has a T30 Torx head and can be used to remove the old screws and replace the new screws.
