UPDATE: STOP USE AND RECALL NOTIFICATION IMMEDIATE ACTION REQUIRED

Subject: 3M[™] 9322A+ Respirator

3M Personal Safety now announces an immediate Stop Use and Product Recall of the 3M[™] 9322A+ respirators. Due to the lack of full adhesive application, the nose foam may separate from the top panel of the 3M[™] 9322A+ respirators. 3M has determined that affected respirators may not meet its expected performance.

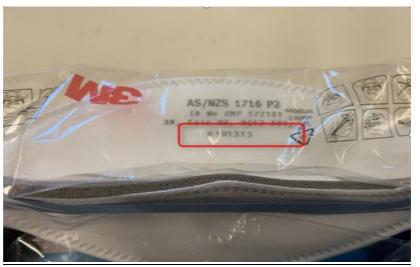
- 1. On the bottom right-hand side of the 3M shipper case label;
- 2. On the bottom left hand corner for the individual box; and
- 3. On the individual respirators

Individual Respirator

If you have any of the affected products, please complete the attached "Stock Return Form" and email the form to your distributor together with an image of the batch number for replacement stock/credit.

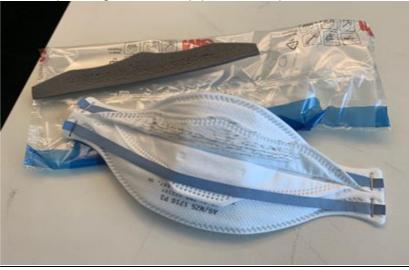
Foam separating from the top panel of respirator
